Case report: Straumann® PURE Ceramic Implant

Michael Gahlert

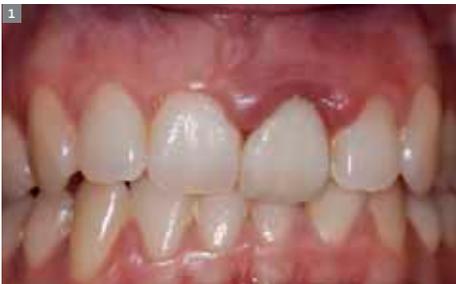
In this 29-year-old female patient, a vertical fracture of tooth 9 led to marginal inflammation, which was particularly noticeable due to the high smile line (Fig. 1). After taking an impression of the upper and lower jaws, a resin-clasped removable partial denture was made to ensure that the gap was filled immediately after the upcoming extraction.

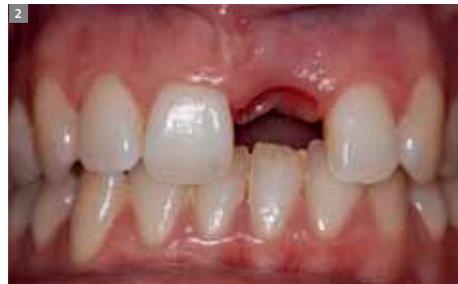
Tooth 9 was extracted (Fig. 2). A buccal bone defect was identified during removal of the tooth. Following extraction of the tooth, the removable partial denture was fitted for optimum passivity. Subsequent treatment was delayed until after epithelialization of the alveolar ridge. Eight weeks after removal of the tooth, a crestal incision was made in the middle of the alveolar ridge with a marginal incision around the neighboring teeth in order to sufficiently reveal the alveolar site with the still existing bone defect (Fig. 3).

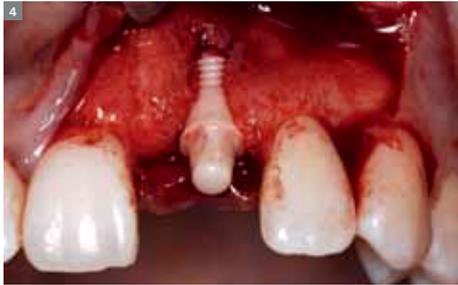
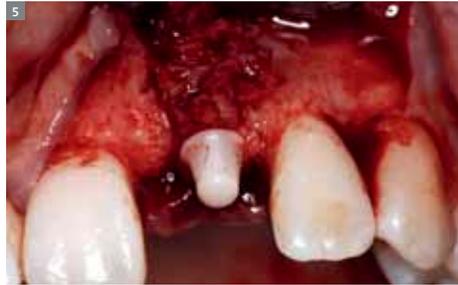
Following was the insertion of the one-piece ceramic implant with the aid of an orientation device to verify the correct axes. The autologous bone harvested during the implantation was used to augment the dehiscence area and subsequently covered

with a collagen membrane (Figs. 4, 5). The follow-up process after surgery was uneventful (Fig. 6), meaning that the implant could be exposed after a healing period of three months.

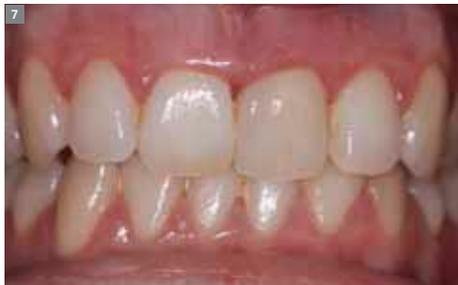
The natural gingival contours were preserved by making a chair side temporary tooth. Subsequently, the final shape was created by a laboratory-made temporary crown which applied papillary compression to the interproximal areas (Fig. 7). The definitive

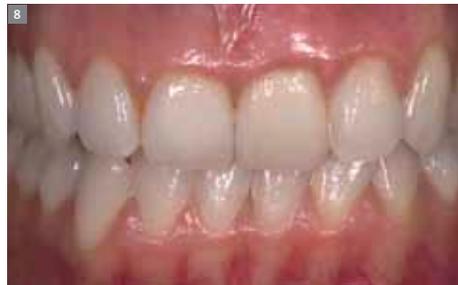
impression was taken in a final step with the manufacture and insertion of a ceramic anterior crown (Fig. 8). The post-operative x-ray shows correct positioning in the bone (Fig. 9).
